PILLAR TALK

Restoring Columns

by Barbara B. Ryan

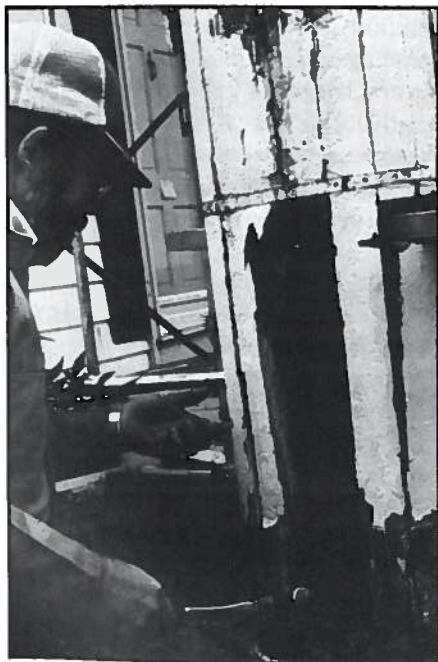
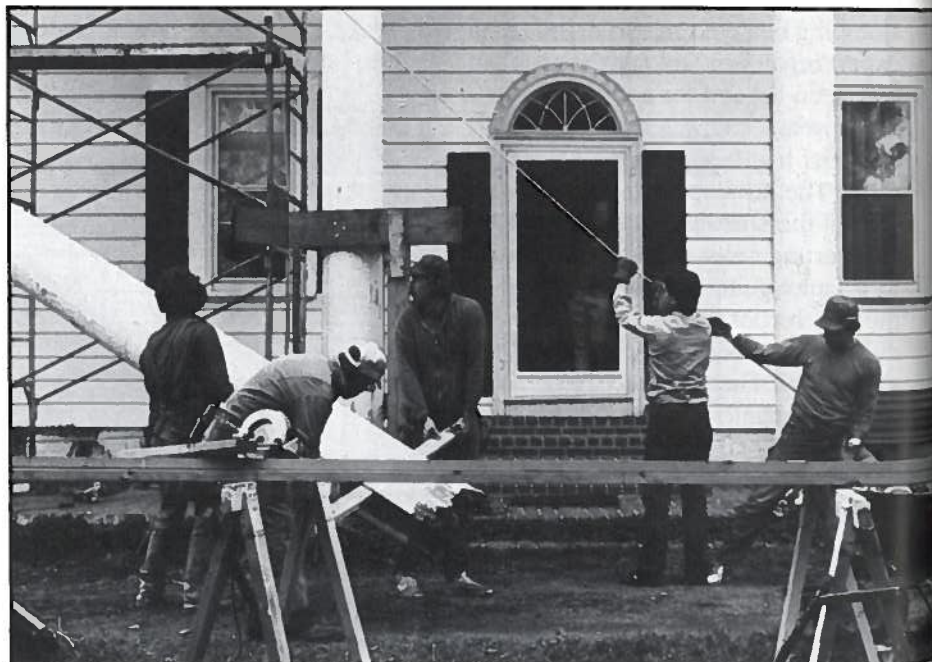
Removing the "worst case": Plunge-cutting the shaft makes room for a 2×4 handle. Then, by rigging with a block-and-tackle, the entire column is lowered to the ground.

jacked up. Next, the shaft was plunge-cut with a chainsaw, and a 2 × 4 was inserted completely through it as a handle. Then a rope was tied to the top quarter of the shaft and run back to a block attached to the scaffold. Once on the ground, the shaft fell apart like a bundle of sticks.

Installing the new column went smoothly. The crew measured three or four times before cutting the new Schwerd shaft, and when it was positioned on its base and plinth, its 19' length was perfect. The capital (which had stuck to the porch lintel when the column was removed) was found to be soft and punky in two of its three sections, so Todd sawed, planed, and generally sculpted matching new pieces from pressure-treated stock.

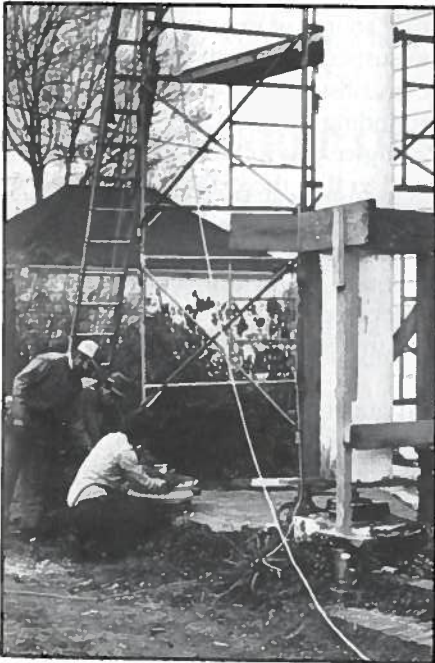
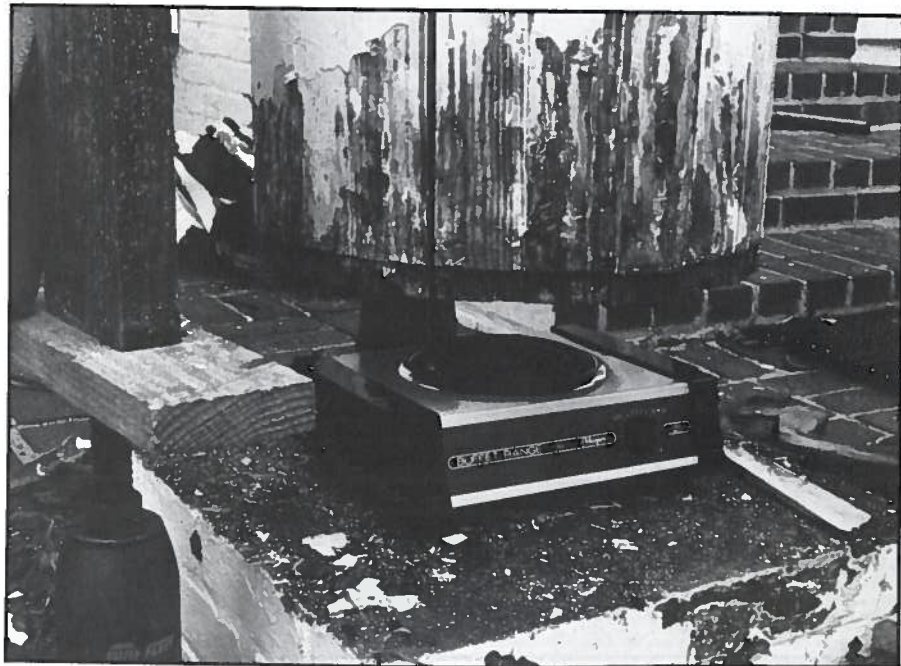
Three four-foot 2 × 10s bolted to each column (left), provided a triangular lifting jig for the hydraulic jacks. Electric heaters dried out the column interiors while the bases were patched and consolidated.

The other three columns needed only raising, so neither taking them down nor shoring up the porch was necessary. Instead, the crew bolted 2 × 10s to the bottom of each shaft to provide lifting points. Then, using three 10-ton hydraulic jacks, the columns were gently raised by these "triangles" — porch roof and all — and the round bases were pulled out from under them. Had our capitals been some moulded composition material, we couldn't have risked crushing them with this jacking technique. But they were wood, and able to bear both the force of the columns being lifted from below, and the resistance of the porch roof pressing from above. Once in the air, both columns and bases were reconditioned with the same epoxy techniques used on the side porch.
