PILLAR TALK

Restoring Columns

by Barbara B. Ryan

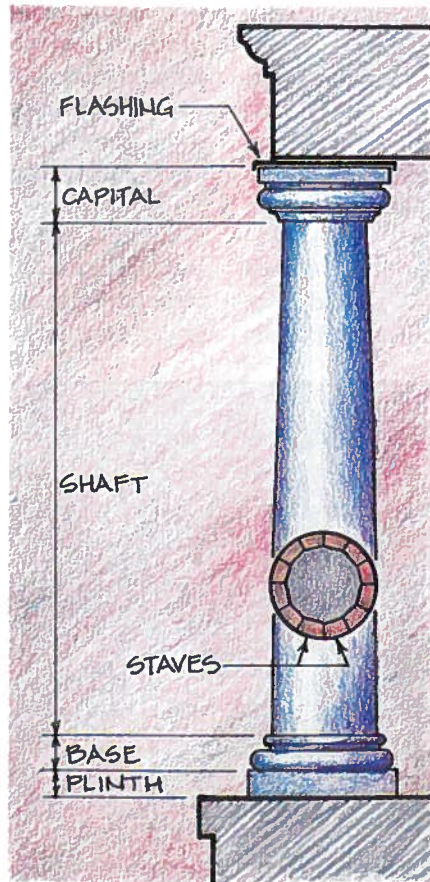
Even before we bought the 18th-century manor house that became our bed-and-breakfast inn, it was obvious that one of the four large portico columns was in trouble. The bottom quarter of its 19' length was rotted, and the staves ranged from partially unglued to totally sprung. Wire strapping betrayed an earlier, not-at-all expert repair (and told us the problem had been around for a while).

For years, rainwater from the portico roof had been running down the pillar. The downspout mounted to the side of the shaft had done a poor job of diverting water from the base; leaks in a faulty gutter elbow (enclosed in the porch roof) had started rot inside the column. Lack of ventilation in the shaft contributed to the damage. The three companions to this "worst case" also looked bad, with their plinths losing paint in large peels that revealed shredded, spongy wood.

Todd Dickinson corroborated John Leeke's judgment. Many of the turned bases and square plinths showed signs of advanced disintegration and were not worth the time to repair. After examining the exterior and drilling shallow holes to test interior conditions, he advised us to replace the worst col-

umn, along with one base on the front portico and all bases on the side porch. Replacements were ordered from A.F. Schwerd.* The plinths specified were cast-aluminum models that stand on small feet — the bottom half of a system for ventilating inside the columns.
